# Resistance to Fracture, Fatigue and Stress-Corrosion of Al-Cu-Li-Zr Alloys

A. K. Vasudevan, R. C. Malcolm,  
W. G. Fricke, and R. J. Rioja

Aluminum Company of America  
Alcoa Laboratories  
Alcoa Center, PA 15069

Final Report  
(Period: 1981 July 01 to 1985 February 28)  
Contract N00019-80-C-0569  
Department of the Navy  
Naval Air Systems Command  
Washington, D.C. 20361

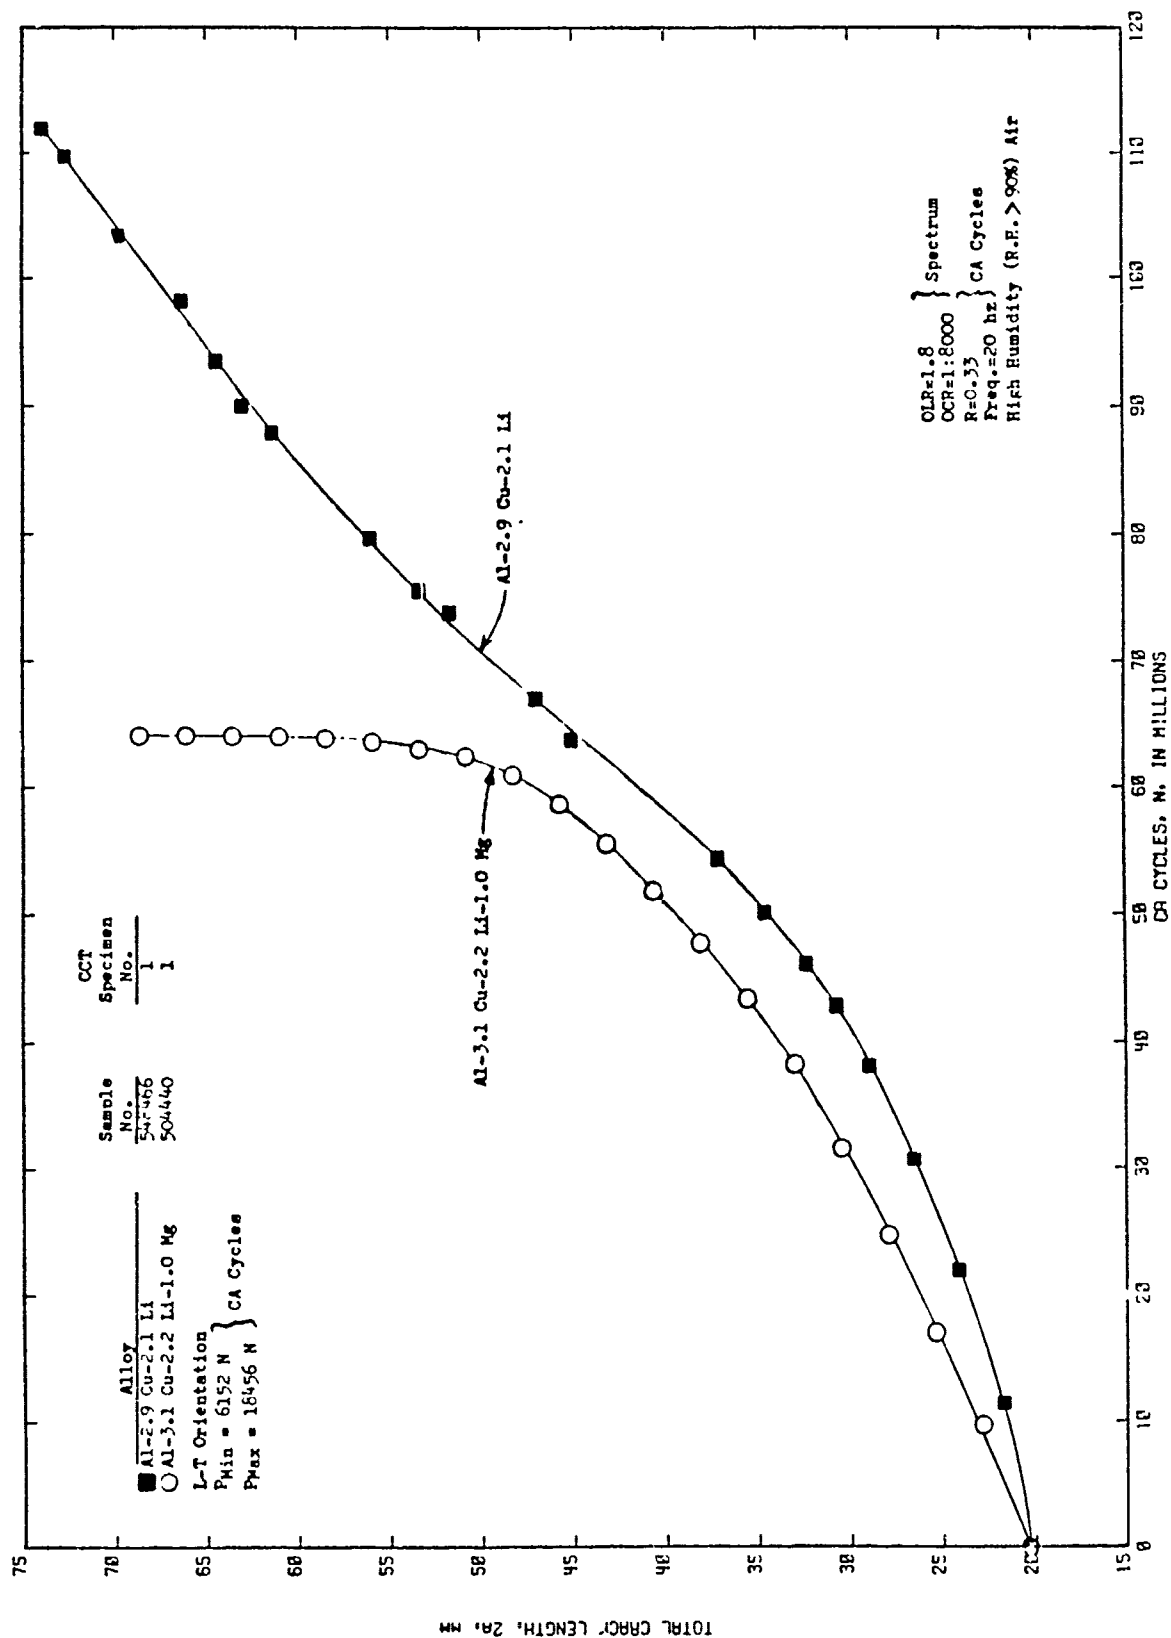
COMPARISON OF TOTAL CRACK LENGTH VERSUS NUMBER OF CA CYCLES DATA FROM SINGLE PERIODIC OVERLOAD FCG TESTS OF LABORATORY FABRICATED T651 PLATES (12.7 MM THICK) OF ALUMINUM ALLOYS (2.9Cu-2.1Li) AND (3.1Cu-2.2Li-1.0Mg)

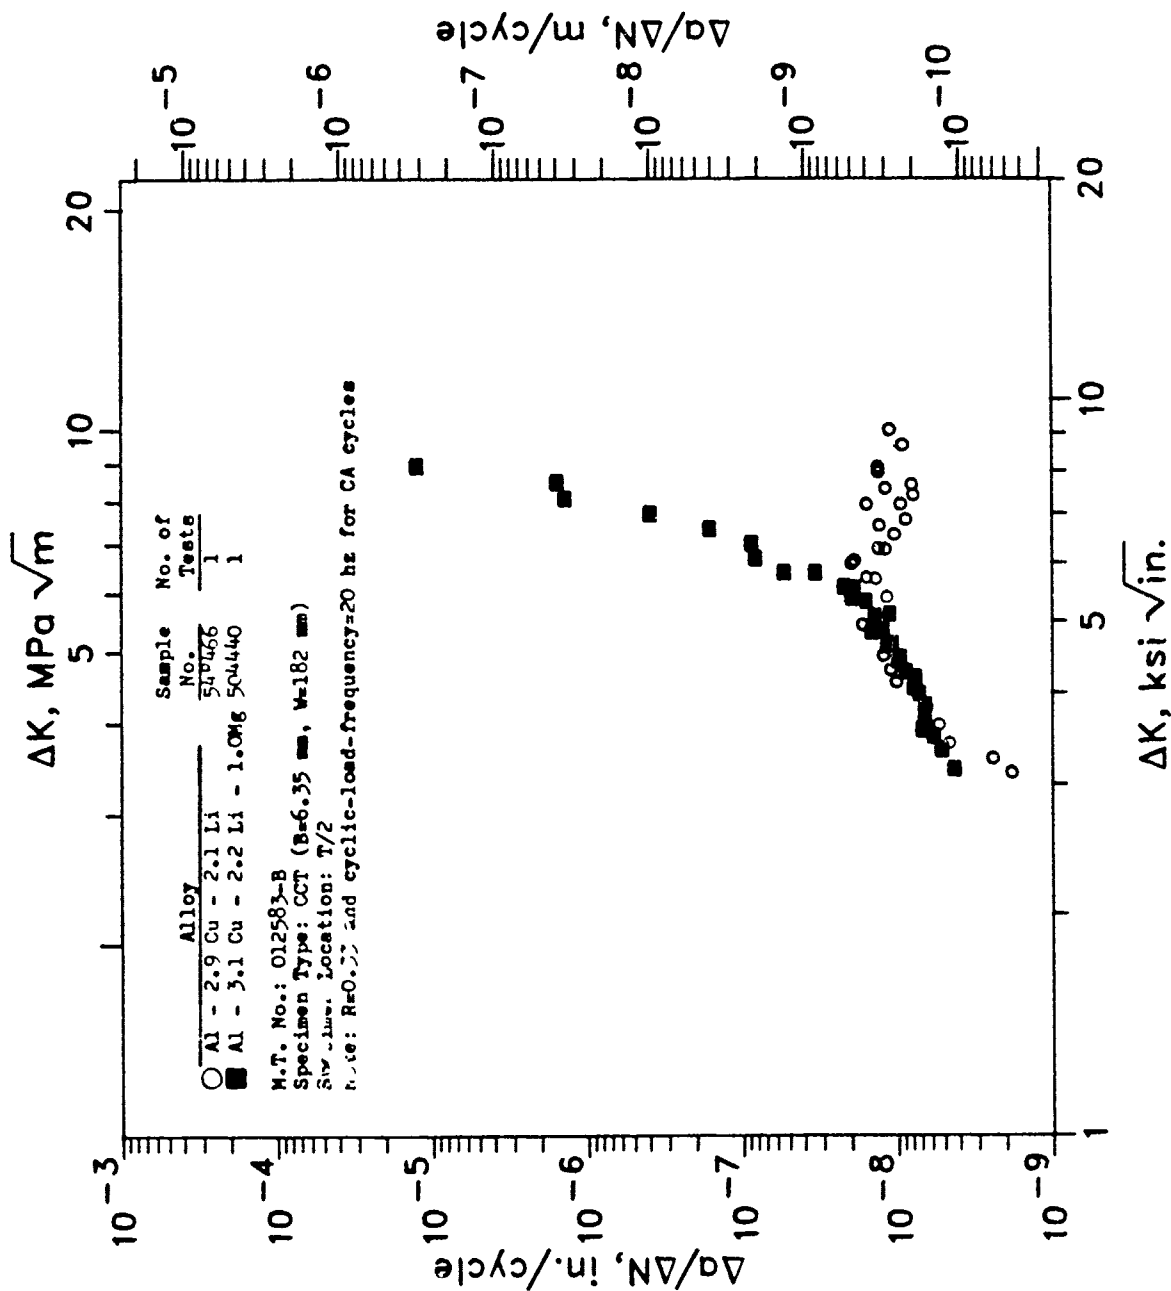
Comparison of Overload Spectrum (OLR=1.3, OCR=1:8000)  
 Fatigue Crack Growth Data for Laboratory Fabricated Plates,  
 0.5-in. (12.7 mm) thick, of Two Al-Li Alloys (T651 Temper)  
 L-T Orientation, High Humidity (R.H.>90%) Air
